### Fixing the leaking rear washer jet

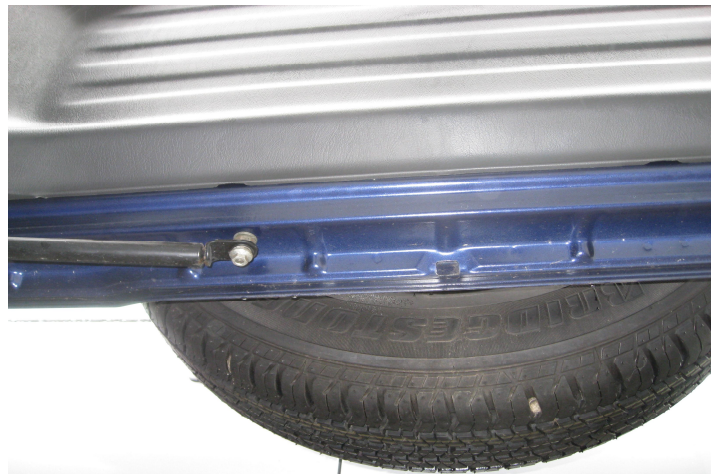
Start off with the two clips on the bottom of the panel

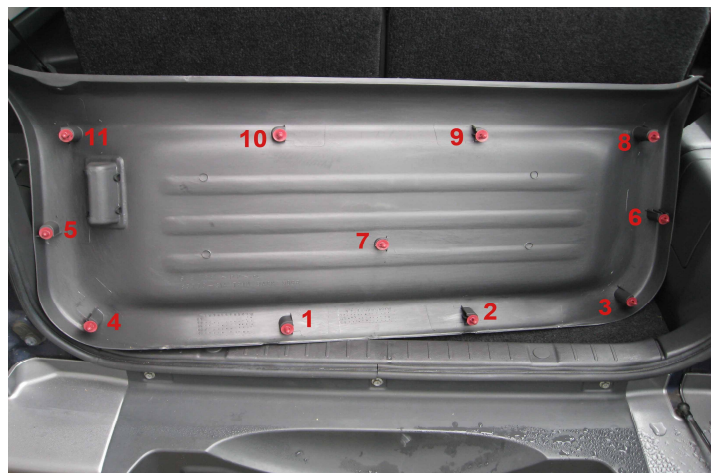
Then pop the rest of the clips in (something like) the following order. 7 is a bit fiddly, you have to get your shaft right up there. Be mindful of the lock mechanism around 5 & 11. You will reinstall the panel beginning with this area.

When the panel is in place, push it home on each clip, from top to bottom in reverse order from the diagram above. Then pull the rear window rubber over the top of it.

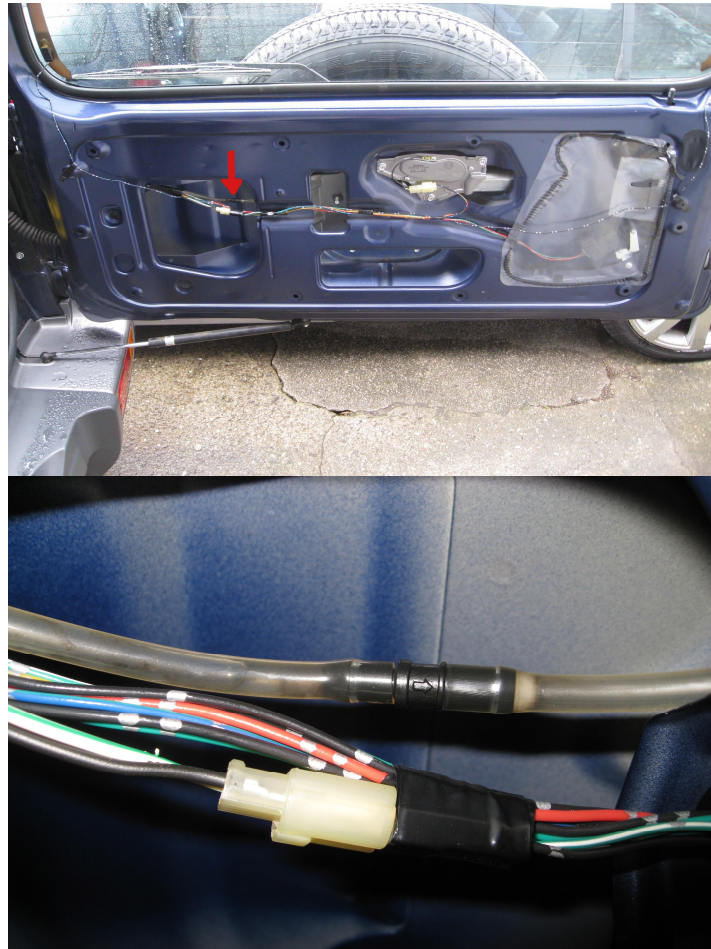
The check valve is here

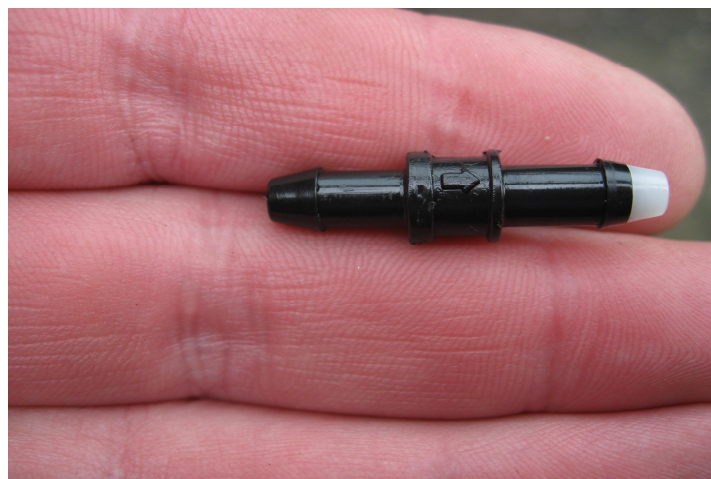
Take the valve out and try to blow hard through it in both directions. If you can, then it's duff. Your new valve should only allow air through in the direction of the arrow

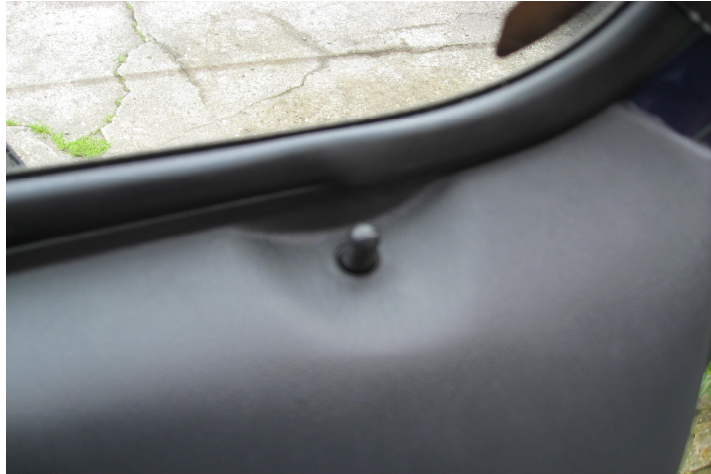
Feed the panel over the pop-up knob

then angle it, about 10 o'clock, to feed the lock lever through the hole on the right. You might need to finger the lever a bit to attract it through the hole.
